## Penetrant System Monitoring Panel Documentation

| SN# 290395-036 | | | | | |

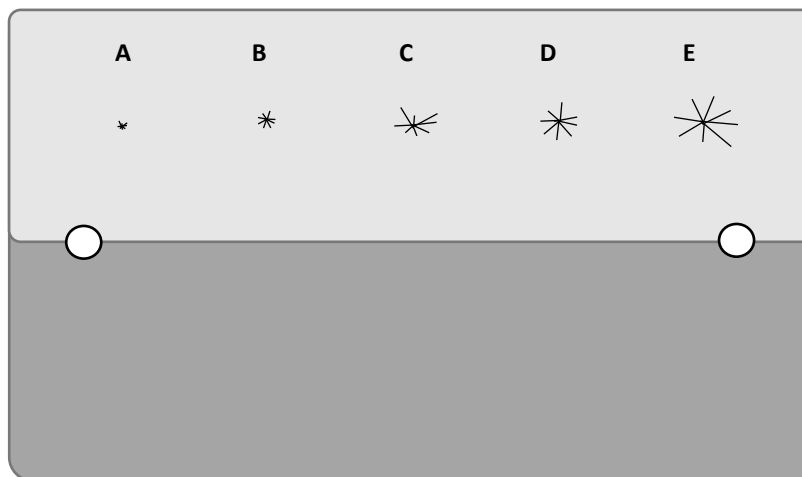
| Crack Position | A | B | C | D | E |
| Photo of Defect | | | | | |
| Magnification Factor: | 1 : 5.5 | | | | |
| Measured Size (Inch) | 0.031 | 0.055 | 0.087 | 0.150 | 0.220 |
| Specification (Inch) | 0.015 - 0.031 | 0.046 - 0.062 | 0.075 - 0.093 | 0.125 - 0.171 | 0.180 - 0.250 |

| Crack Depth | .0025" ± .0001" | 63 µm ± 2.5µm |

Measured with Keyence IM 8010  
Calibration No. RM4133305
